Final report RL 2012:21e

**Serious incident on 16 of January 2010 to
aircraft EP-IBB at Stockholm/Arlanda
Airport, Stockholm county, Sweden**

Ref.no. L-02/10

2012-12-28

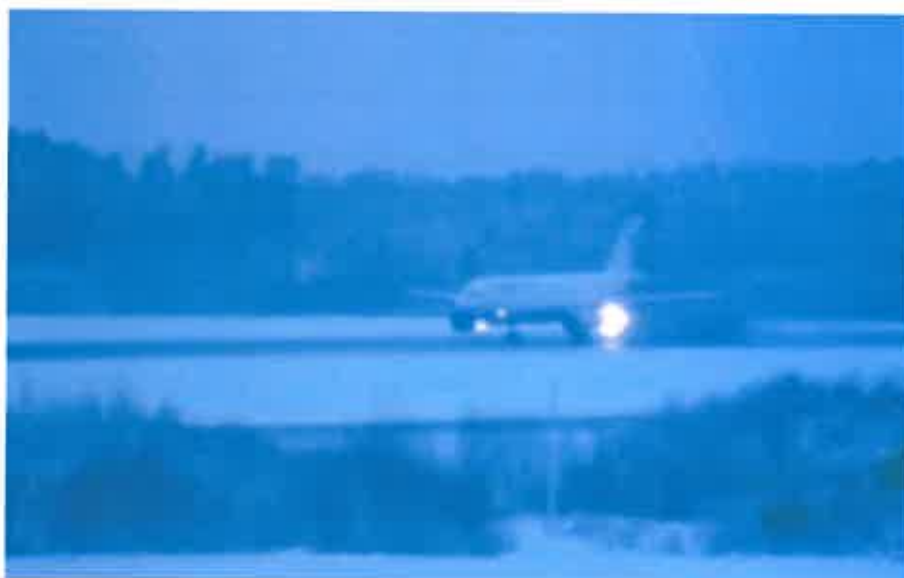
Fig. 2. Image from video. Photo: Saeid Cedighi Chafjiri.

The speed when the engine failure occurred was approximately 54 knots, but the aircraft continued to accelerate to approximately 59 knots (110 km/h). The incident occurred after rolling approximately 250 metres along the runway. The image in Figure 2 above has been obtained from a private video taken from the viewing terrace at Arlanda Airport during the sequence of events. The engine failure started with a puff of smoke and was quickly followed by three flames of varying size within the space of 0.77 seconds.

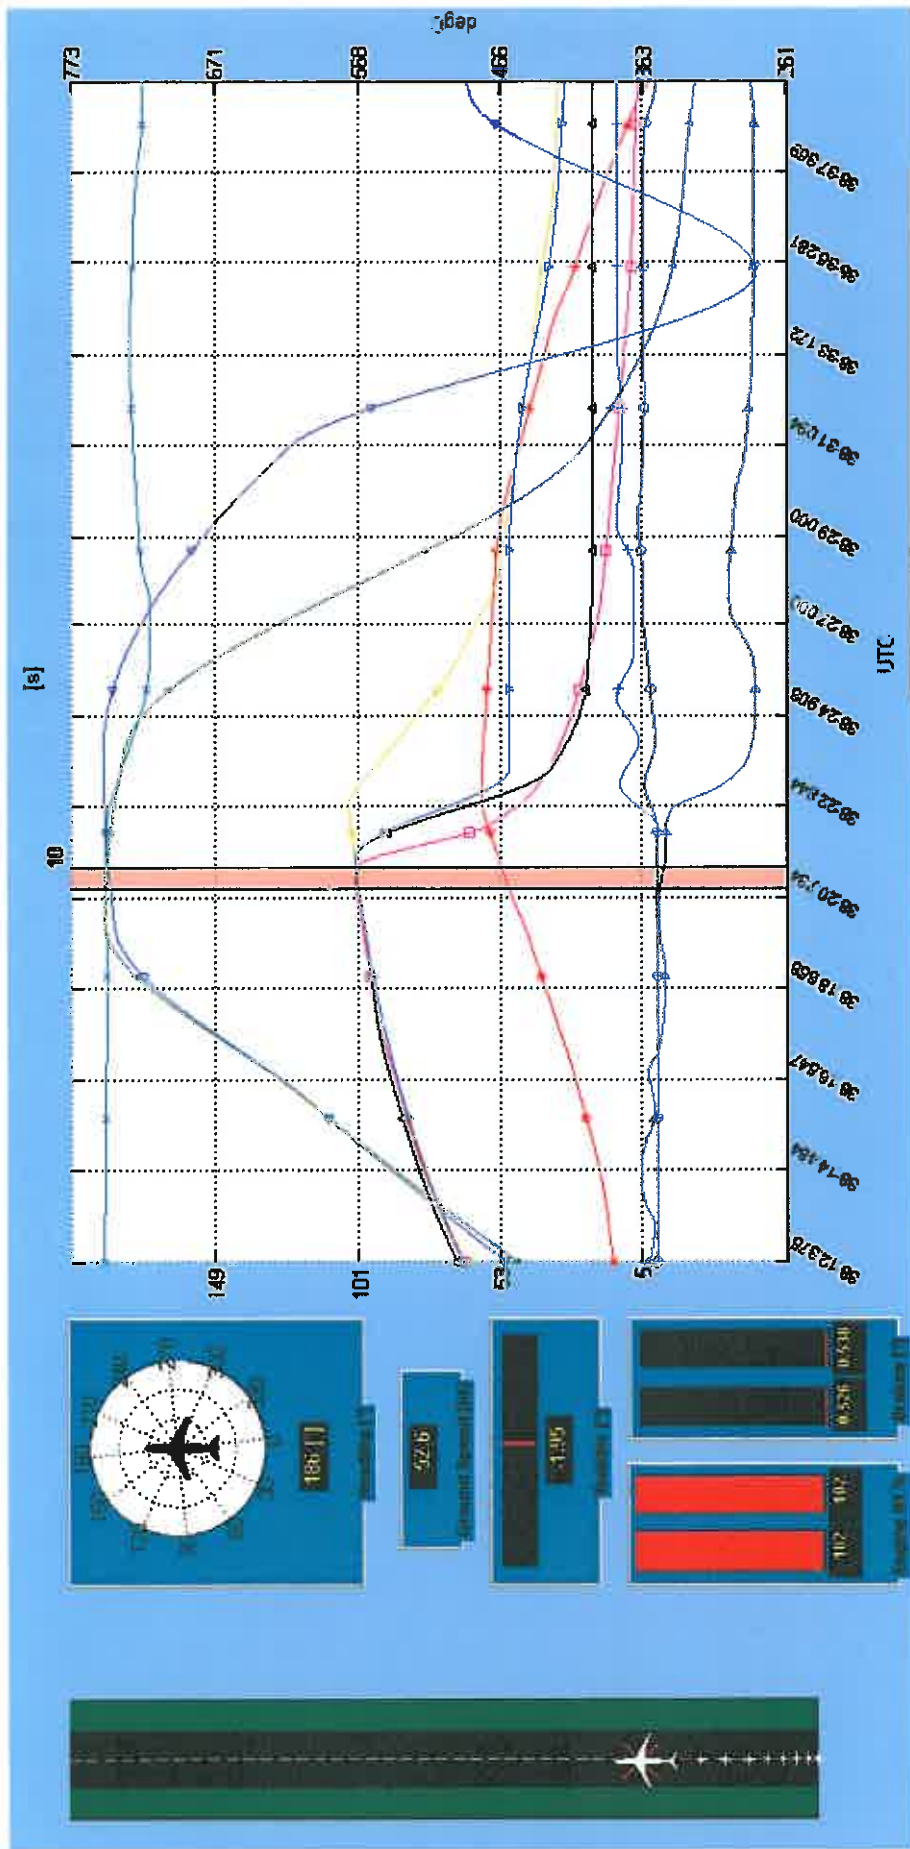
Fig. 4. Point of time for loss of engine power. Based on FDR data.

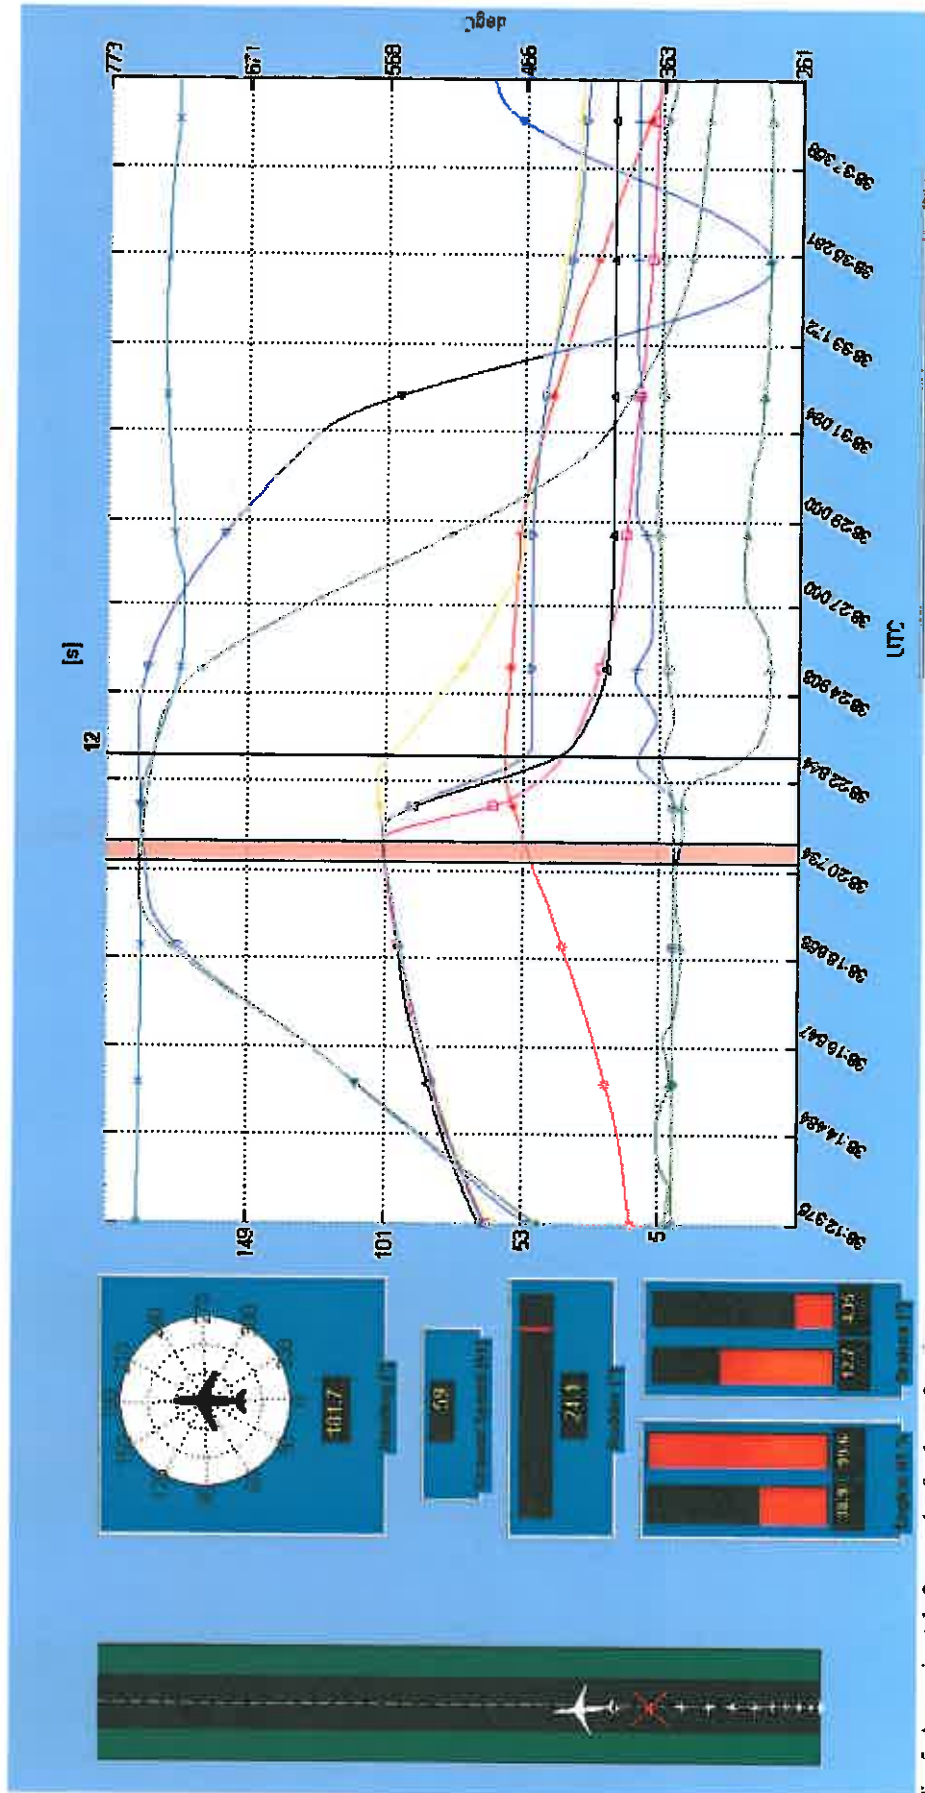
Fig. 5. Approximately 2 seconds after loss of engine power. Based on FDR data.

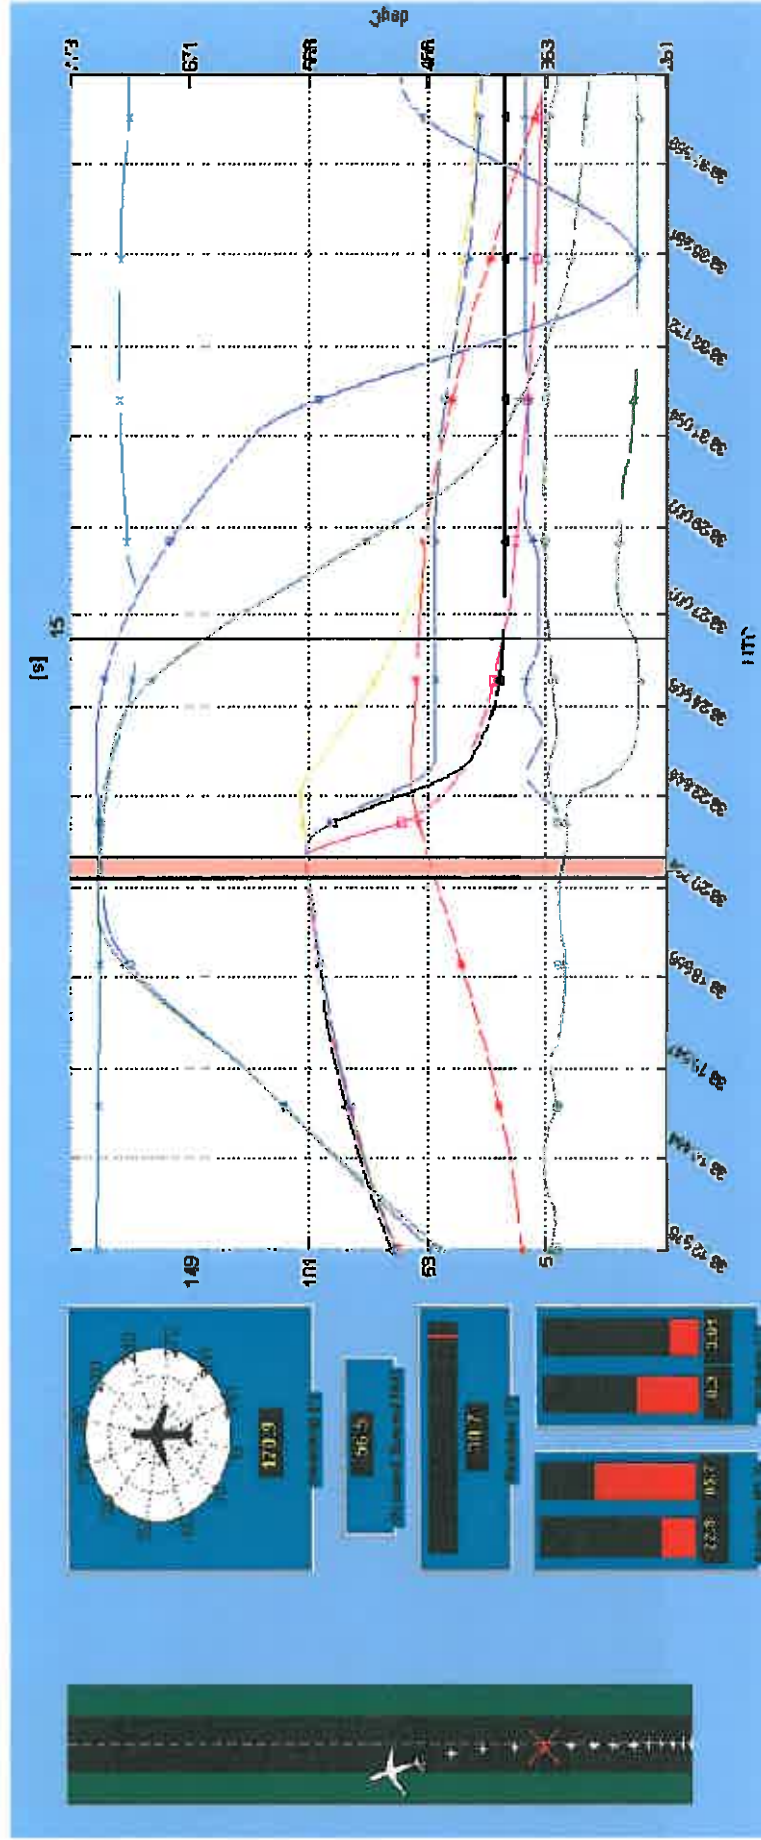
Fig. 6. Approximately 5 seconds after loss of engine power. Based on FDR data.

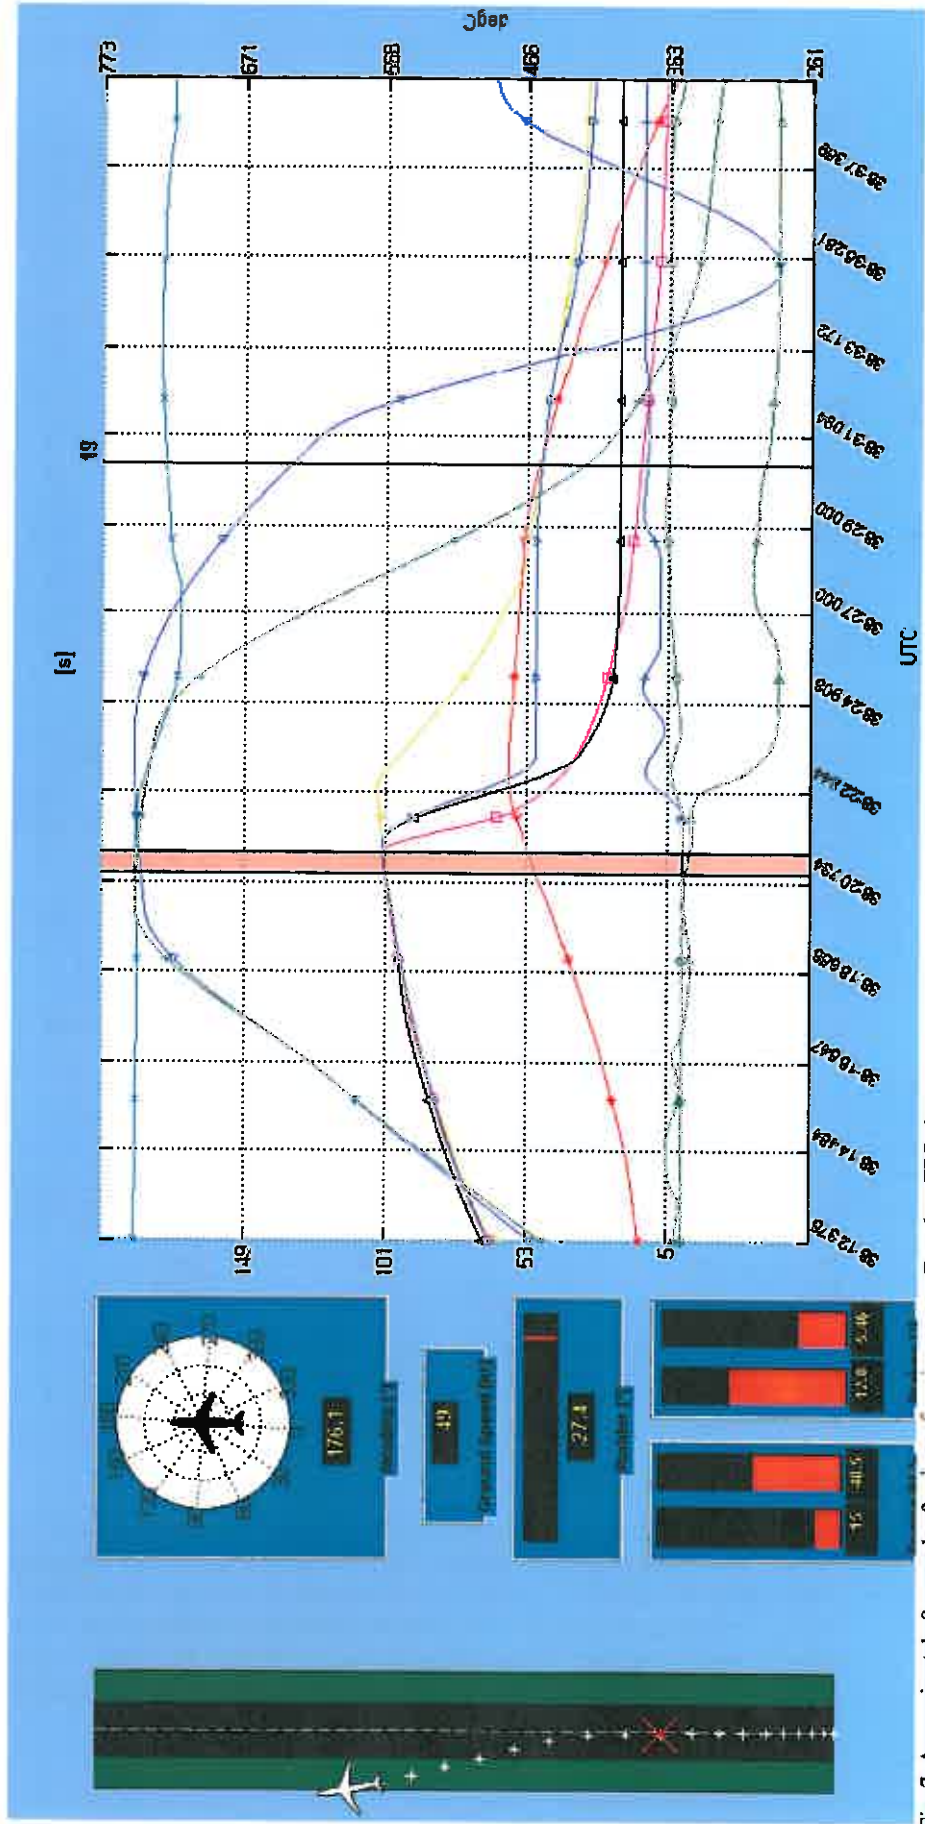
Fig. 7. Approximately 8 seconds after loss of engine power. Based on FDR data

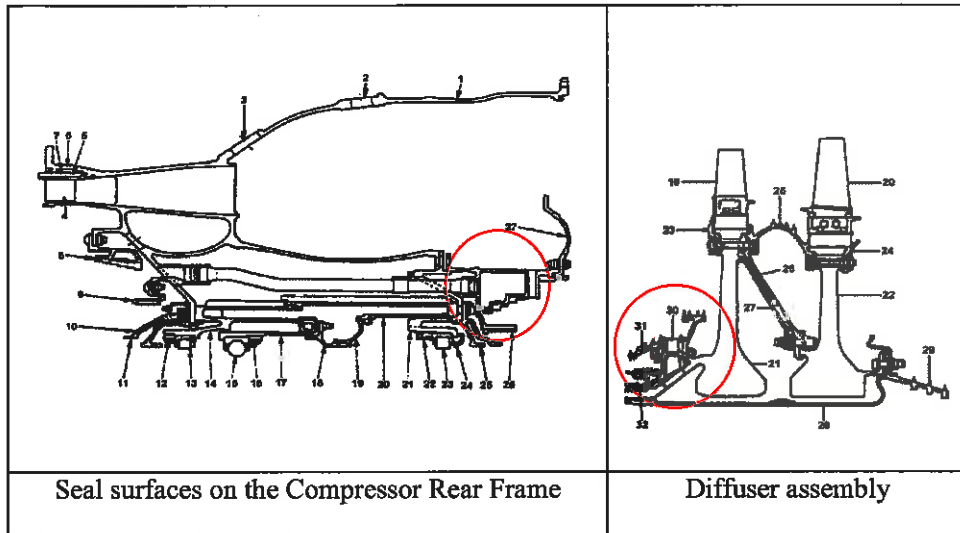
Fig.12. Diffuser Assembly and Compressor Rear Frame.

If the aft air seal separates, seal debris which enters the core flowpath in addition to the loss of pressure balance will result in an engine stall event by the result of the disruptive core airflow. In the investigated incident, the separated debris which entered the core flowpath resulted in significant downstream damage which resulted in high exhaust gas temperature (EGT) and loss of fan speed (N1 system) from the LPT blade damage.

In the drawing below, a red circle marks the static seal surfaces on the Compressor Rear Frame and the rotating Diffuser Assembly on the High Pressure Turbine.

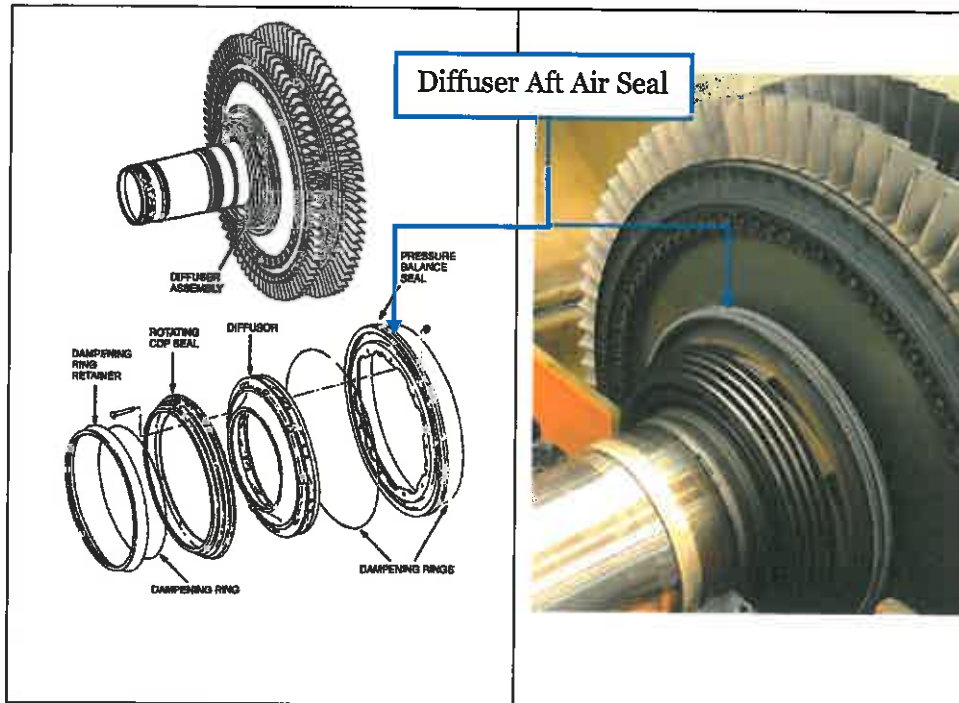
Fig. 13. Diffuser Aft Air Seal.

The seal teeth on the air distributor's aft seal (Diffuser Aft Air Seal), termed Pressure Balance Air Seals (see Fig. 13.), become worn and can in some cases be repaired. Engine Manual section 72-53-07, repair 003, provides a Dabber TIG Weld Repair of the aft seal teeth which adds material to the teeth edges in the form of weld beads on the flange, which are then turned down on a lathe to the correct tooth dimensions. Section 1.18.1 describes the procedure schematically.

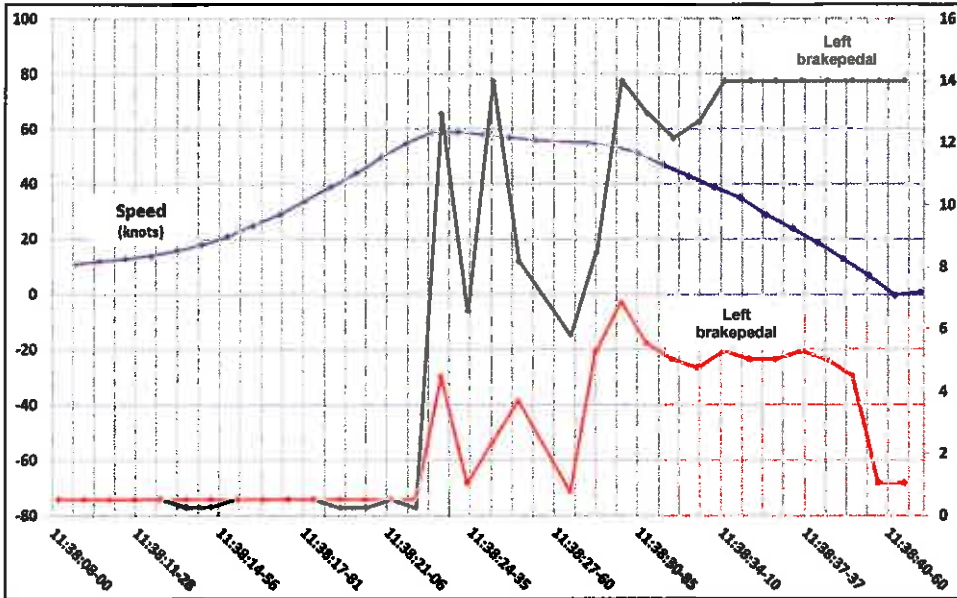
Fig. 21. Brake pedal angles.

The recording of the brake pedal angles has been secured, for the right and left pedals, respectively. The pedals for right and left pilot are mechanically interconnected, which means that it is not possible to determine which one of the pilots has pressed down any of the brake pedals. Only the joint brake angle has been recorded. The brake pedal angles are presented in Fig. 21 below. A value of 14 represents the maximum displacement.

From the diagram in Fig. 21, it can be noted that the recorded pedal displacements follow each other at different levels during the sequence, where the right pedal has been recorded with values corresponding to around half of the value for the left pedal.

Maximum displacement has been recorded from the left brake pedal during the final phase until the point when the aircraft stops. During this phase, the value from the right pedal decreases and approaches zero when the aircraft stops.

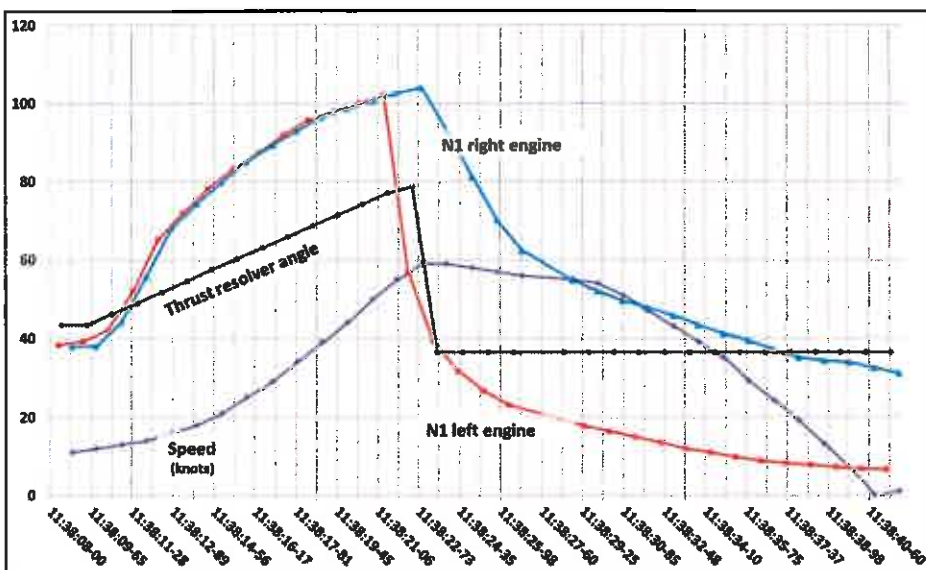
Fig. 22 Rpm N1, throttle angle, aircraft speed.

The engines' rpm N1, thrust lever angle, and the speed of the aircraft are presented in Fig. 22 below. The red line represents the left engine, i.e., the engine that failed.

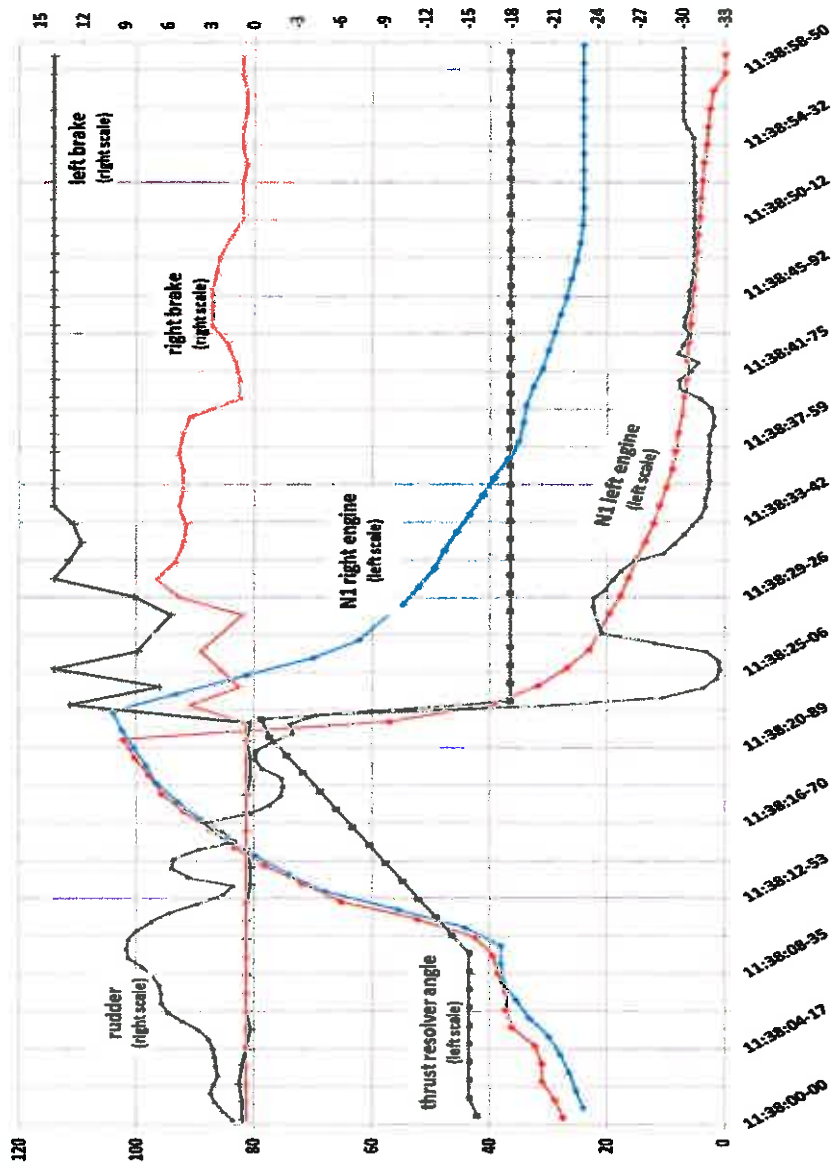
Fig. 24. Data from the FDR.

The enlarged diagram overleaf – Fig. 24 – illustrates the times with raw data from the FDR at the time of the loss of engine thrust itself, from 38:21 to 38:25. The first point on the N1 line is also the highest point (102.25%). Among other parameters which could be noted from the FDR readouts, it can be seen that aileron was applied (the steering wheel on the steering column was moved to the right),

and that the steering column was pulled back a little. These actions were initiated when the aircraft had already begun the veer to the left.

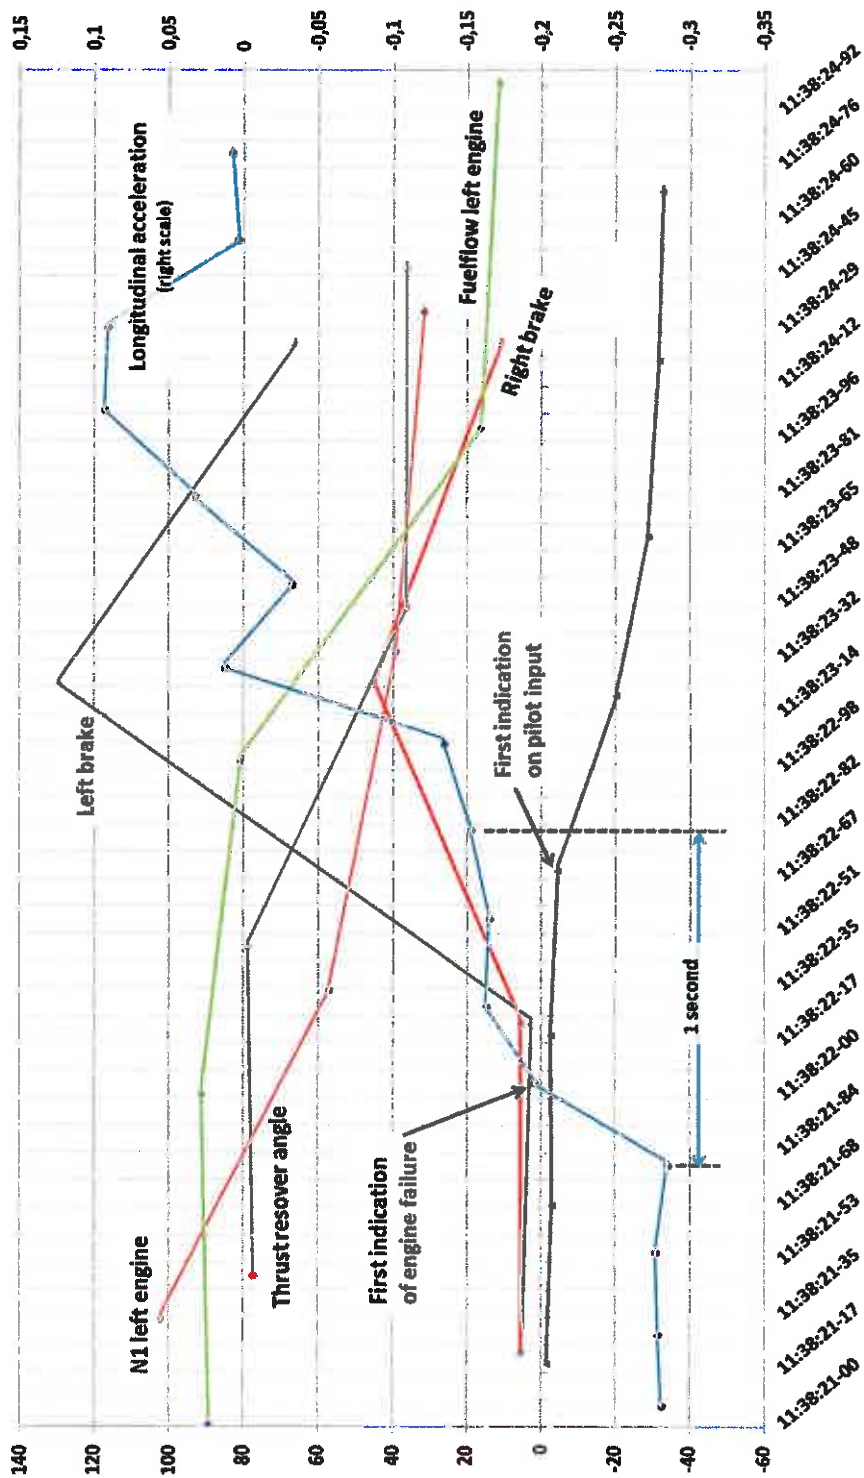
Fig. 25. Data from the FDR.

The pilots' reaction to the loss of engine thrust can be seen in the thrust lever angle, rudder and the brake pedal angles. The pilots' reaction begins at 38:22.18 hrs at the earliest (rudder) and at 38:22.68 at the latest (rudder position recorded at 2 Hz, i.e., two times per second). At 38:22.18 hrs, the rudder passes -20° (turn right). The first value recorded when the brake pedals had begun to be used is at 38:23.25 hrs (they are recorded at 1 Hz). The left brake pedal was at that point depressed at around 92% of maximum displacement, and the right pedal at around 29%. The thrust lever angle is recorded at 1 Hz, and at 38:22.46 hrs, the thrust lever positions were still unchanged. At 38:23.46 hrs, the thrust levers had been retarded down to ground idle. The sequence can be seen in Fig. 25.

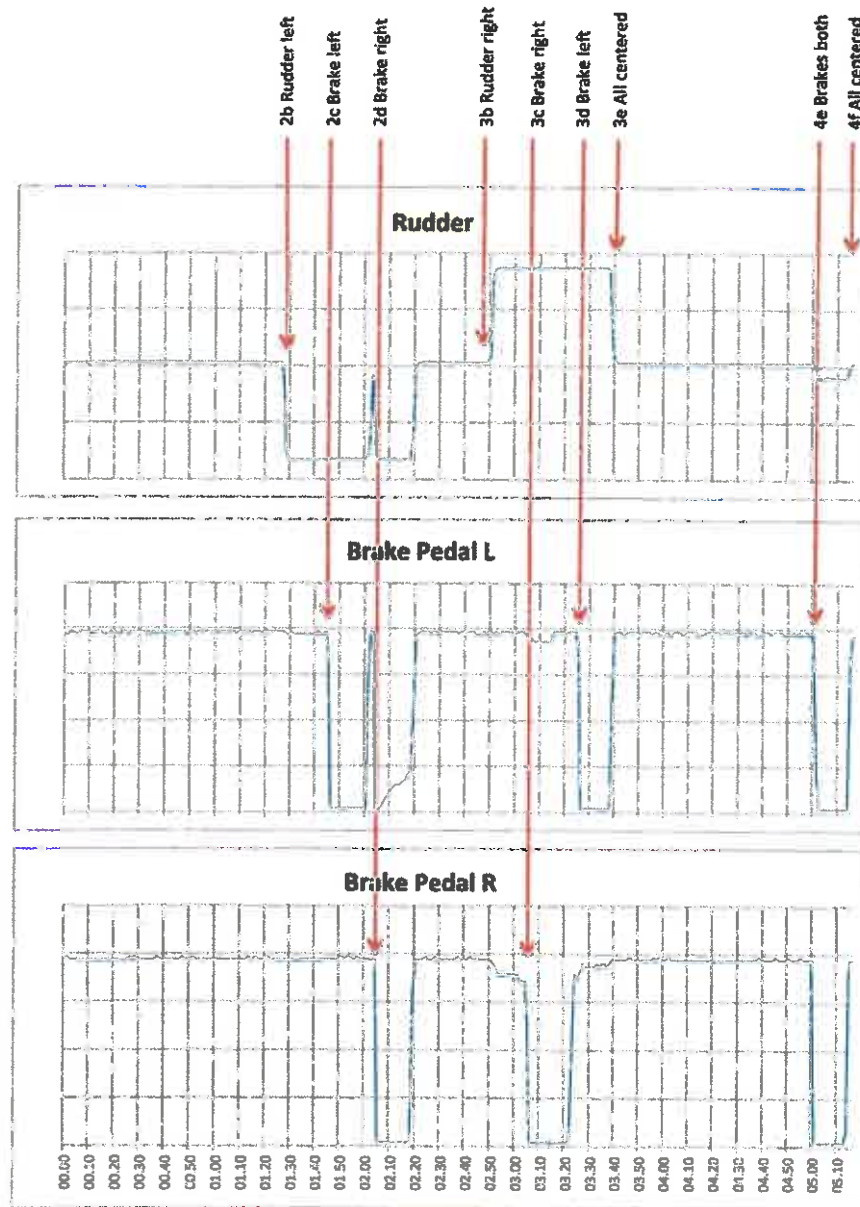
Fig. 26. Section of a graphical presentation of the data recorded during testing. Terms on the upper edge refer to SHK's test schedule. The bottom scale represents a time axis.

When the recorded data were extracted, it was established that there were no malfunctions or deviations, compared with the original recordings from the incident. Upon full displacement of left and right brakes, the corresponding maximum values had been recorded in the FDR. In the illustration above, it can also be understood that full brake displacements were registered irrespective of whether the rudder pedals were in left, right or neutral position. All recorded values corresponded fully to the movements and manoeuvres carried out by the test persons in the cockpit.

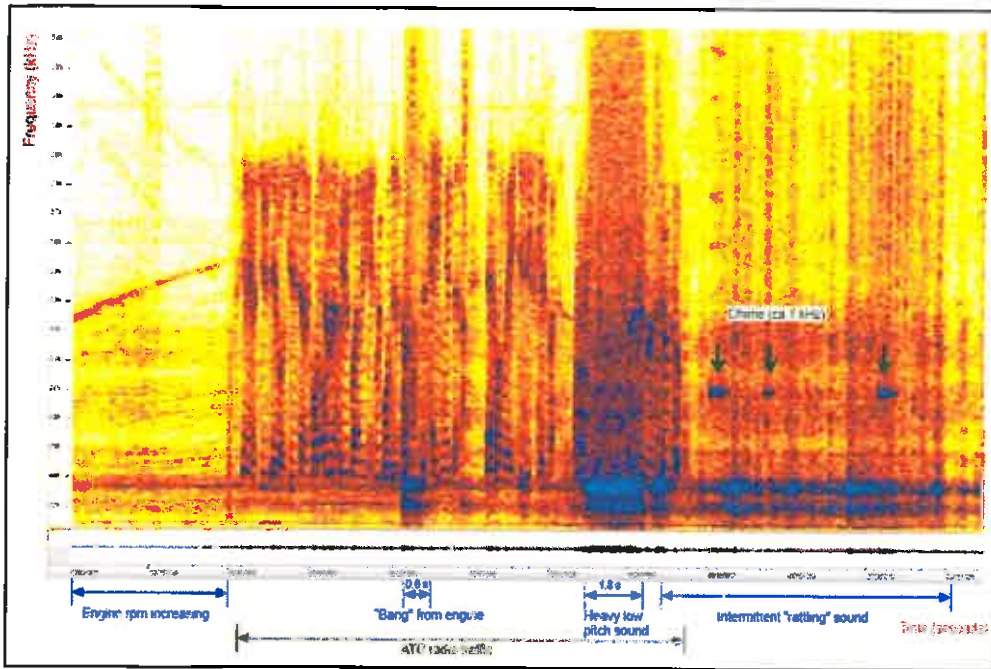
Fig. 27. Sonogram from channel 2 of the CVR. Graphics: Magnic AB.

The sonogram describes how sound can be visualized in the frequency plane, with time on the horizontal axis, where in addition to the “bang”, the low-frequency sound recorded approximately 4.5 seconds after the engine failure can also be noted.

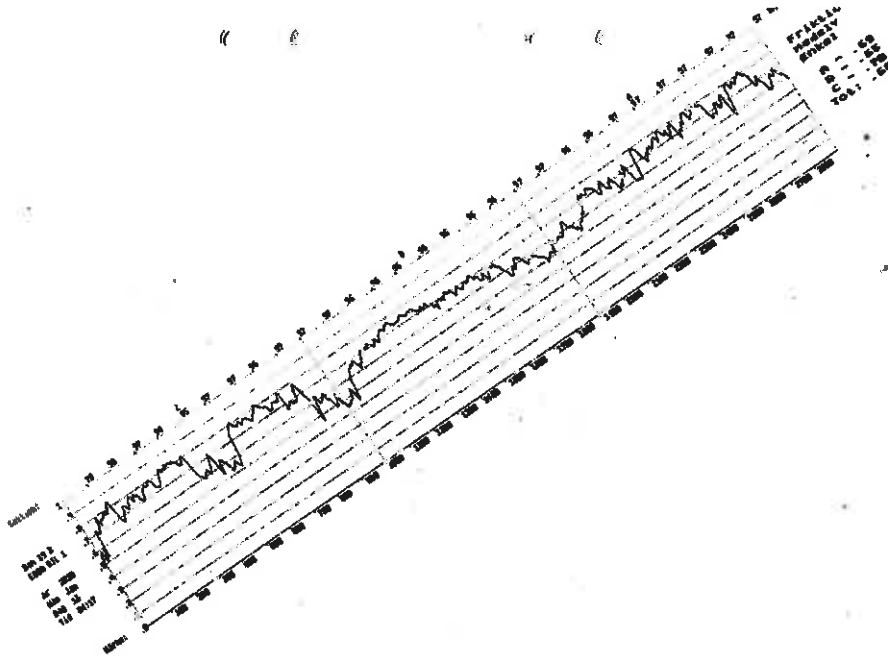
Fig. 31. Friction measurement at 04.17 hrs on runway 19R.

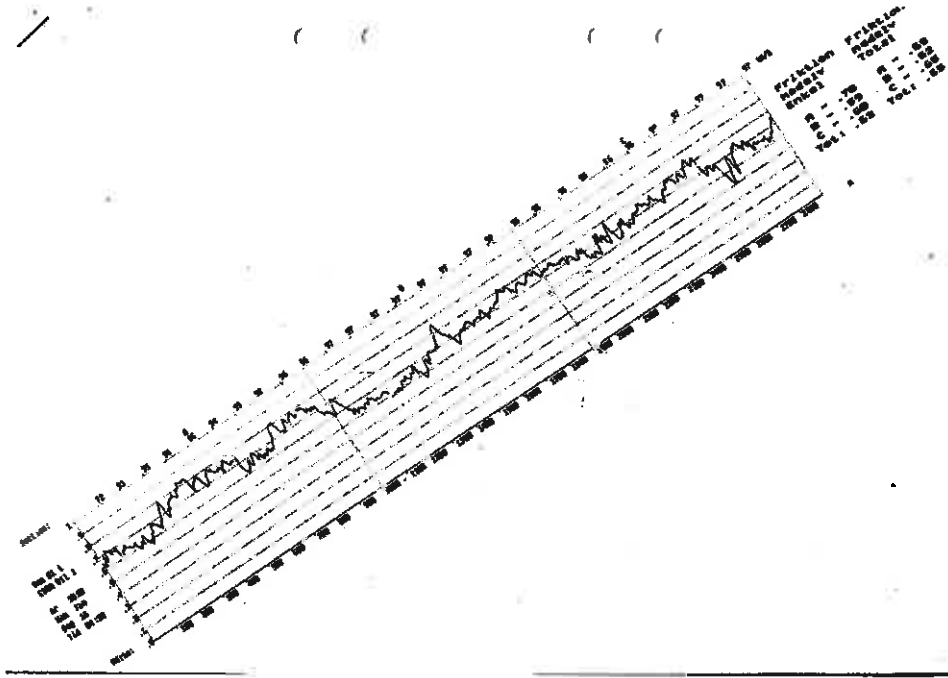
Fig. 32. Friction measurement at 04.20 hrs on runway 01L.

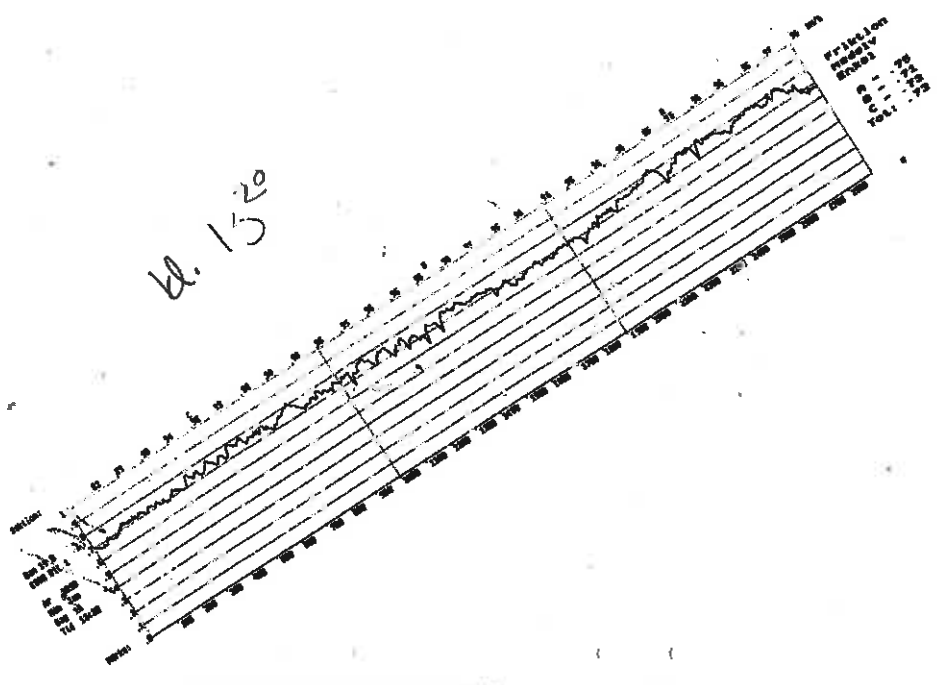
Fig. 33. Friction measurement at 13.20 hrs on runway 19R.

Approximately 35 minutes after the incident, a new friction measurement was carried out on runway 01L/19R, Fig. 33. This friction measurement shows generally higher values, 75, 71 and 73 for the respective sections and a mean value of 73. The difference between the highest and lowest friction values was on that occasion approximately 19.

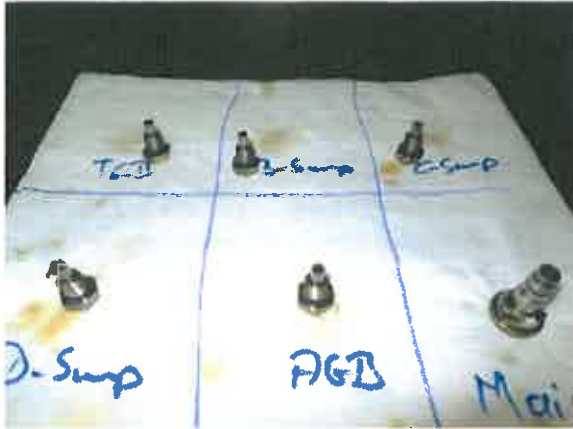
Initially, before the sequence of the engine failure was clarified, impurities in the oil system were a lead in the investigation. Inspection of the chip plugs⁴⁶ gave a clear indication that the oil system was not contaminated and that no bearing race was on the way to being damaged.

Fig. 41. The oil system's chip plugs; only the D sump (LPT) plug had traces of magnetic material. The number of chips was normal for the operating time. Photo: SHK.

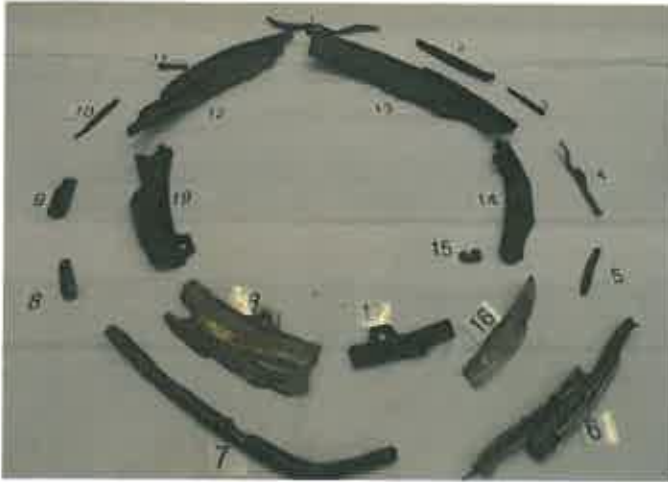
Of the parts analysed, it was discovered that the majority had secondary damage and that the sequence of failure on the diffuser aft air seal was the primary damage in a sequence of failure that is unknown at this time. LHT concluded that the seal came loose due to micro cracks in the nine attachment lugs that hold the seal against the diffuser. The attachment lugs are to have come loose, and the ring to have expanded radially outwards and come into contact with the stationary honeycomb seal. See Fig. 42.

Fig. 42. Fragments of the diffuser aft seal analysed by LHT.
Photo: LHT.

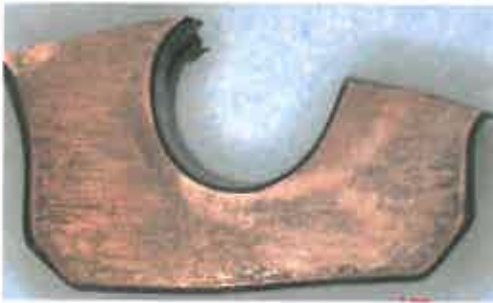
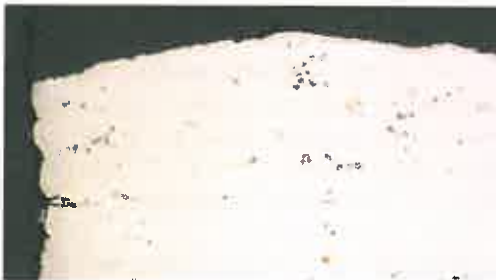
Fig. 43. Cross sections of the attachment lug with micro cracks, diffuser aft air seal. Photo: LHT.

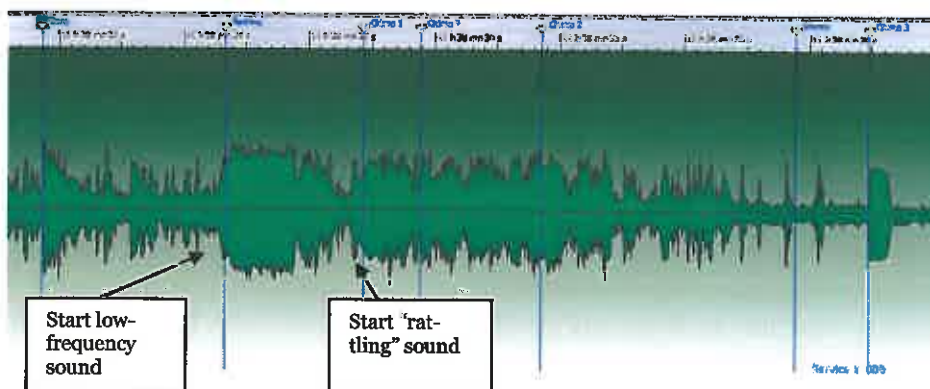
Fig. 54. Audiogram of parts of the incident. Graphics: Magnic AB.

At 26.5, a loud, low-frequency sound is recorded, which continues until 28.3. This sound is probably caused by the commander activating the nose wheel steering via the steering wheel at this point in time and turning the nose wheel to its maximum displacement angle. The increasing angle results in the nose wheel being more or less transverse against

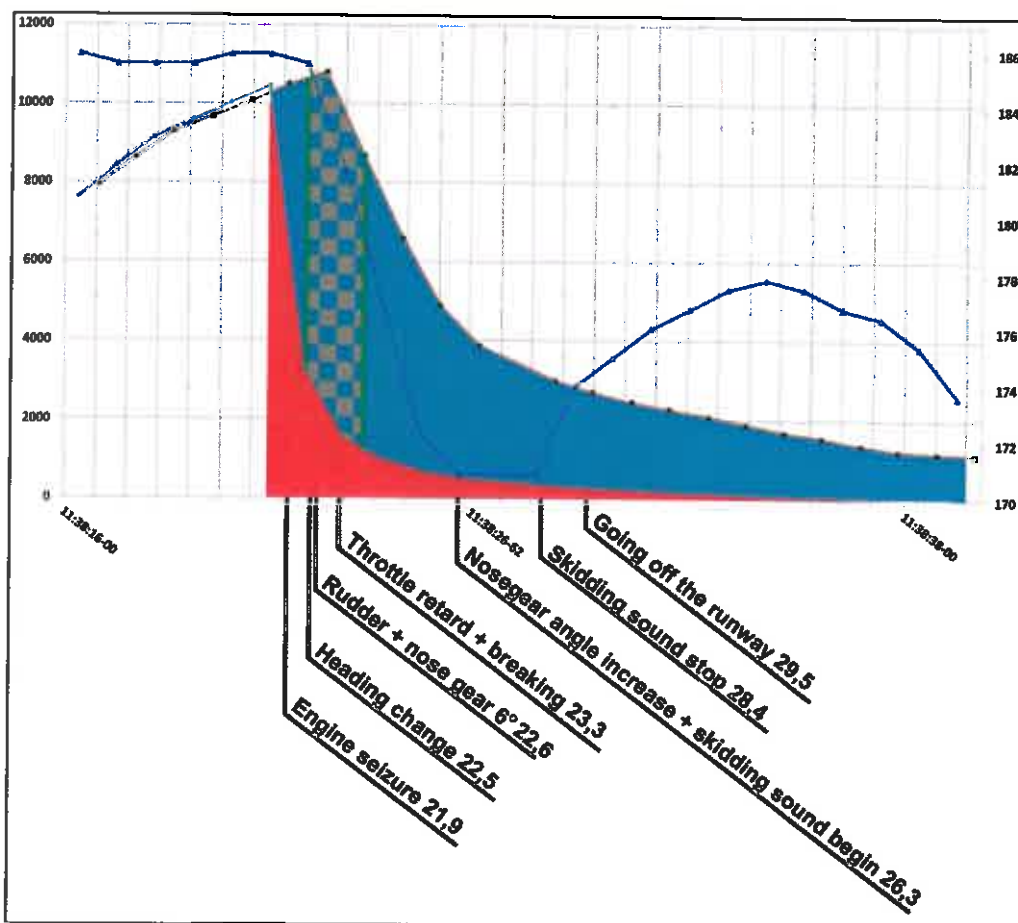
Fig. 56. Illustration of the energy from the engines including timeline. See also fig. 23.

In the diagram in Fig. 56, relevant data from the FDR, with the area of high yawing moment inserted, has been combined with the analysed timeline of the incident. The diagram shows clearly that the force from the excess moment from the situation of asymmetric thrust almost immediately produced the veer.

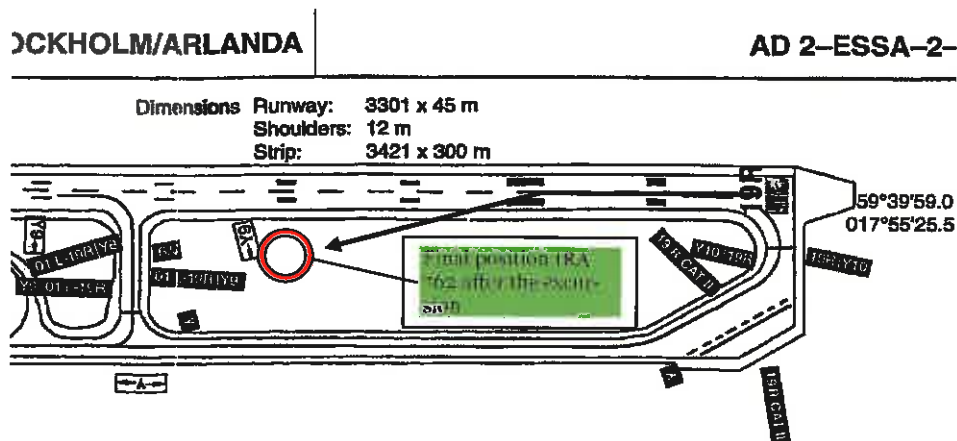
Fig. 59. Overview of the incident area at the airport.

Had the incident occurred just a few seconds later, the aircraft would most probably have run onto taxiway Y9. At the holding point on this taxiway, aircraft are often lined up awaiting take-off. On average, 40% of all take-offs from runway 19R are carried out from the intersection at taxiway Y9.

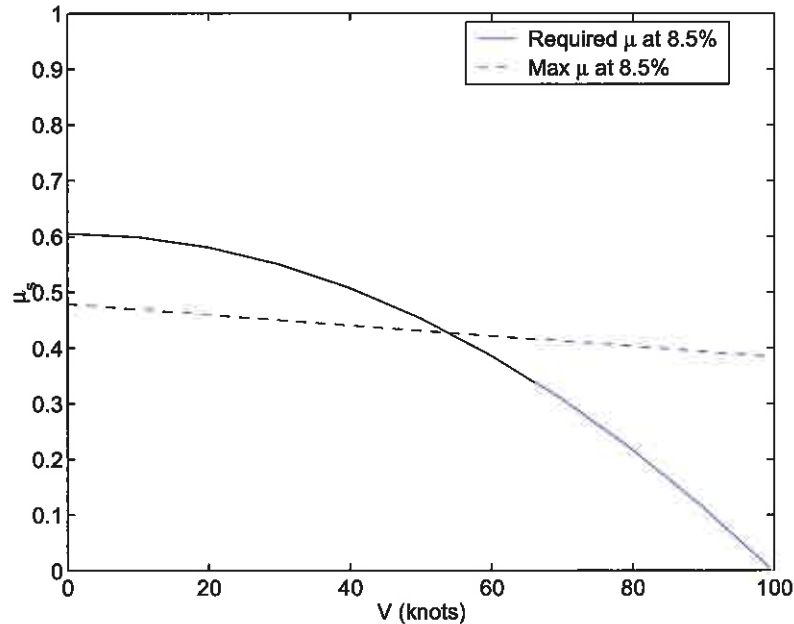
Figure 5.1: Required and available μ_s at different speed.

At low speed directional stability appears not to be possible in slippery conditions. But as speed increases, the yaw moment induced by the maximum deflected rudder starts to help and at 100 knots there is no side force on the nose landing gear.

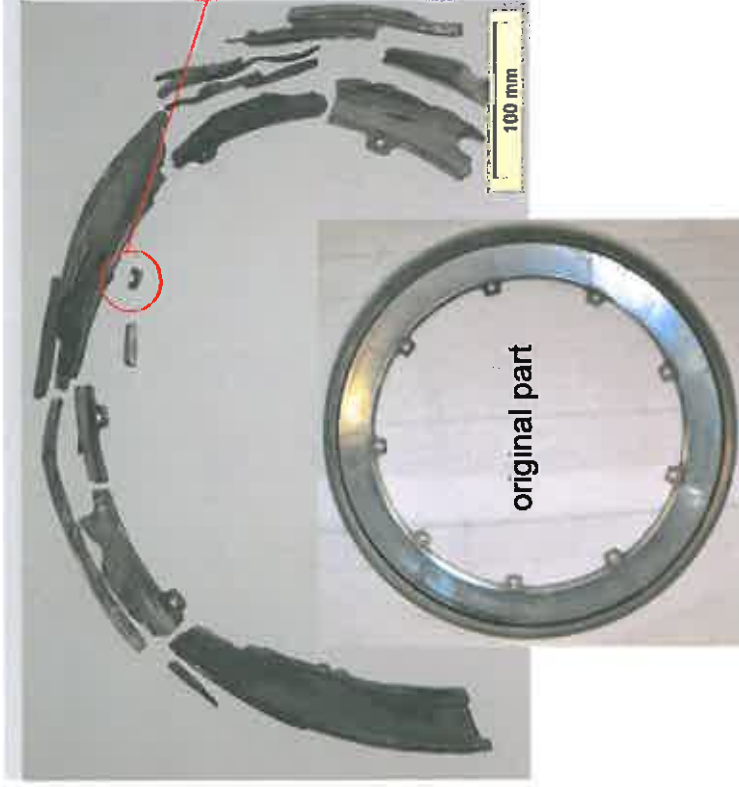
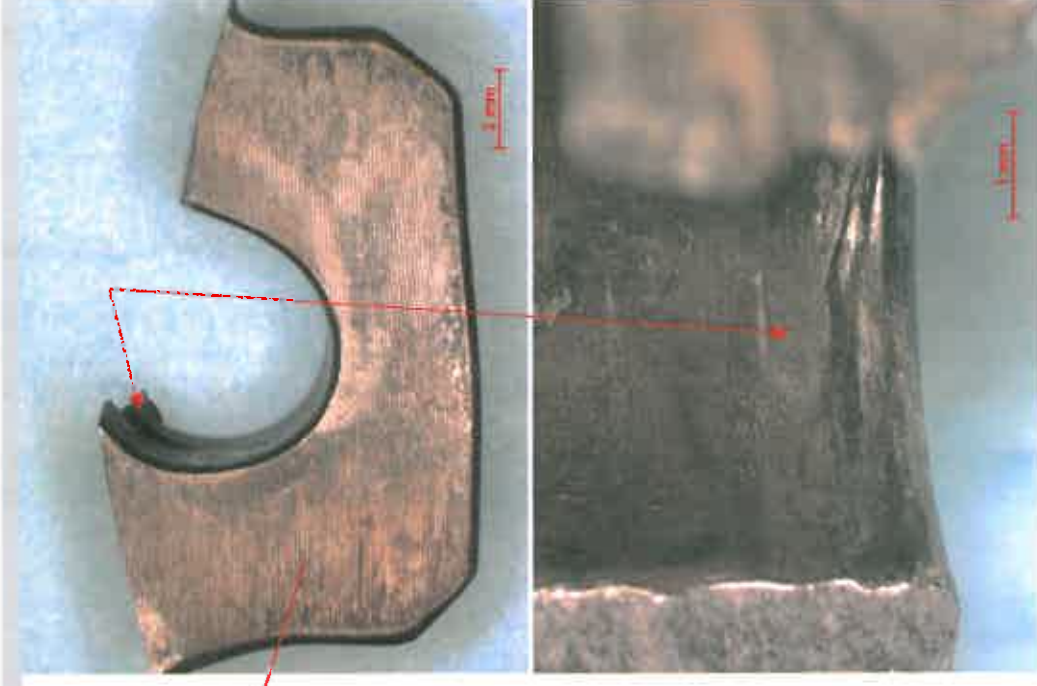
HPT Diffuser Aft Seal

Fractured lug with post fracture damaged fracture faces exhibiting internal mechanical damages

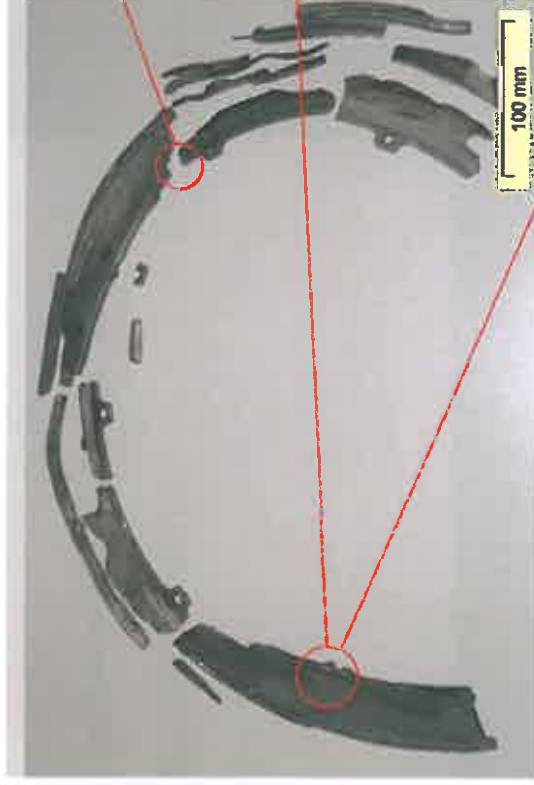
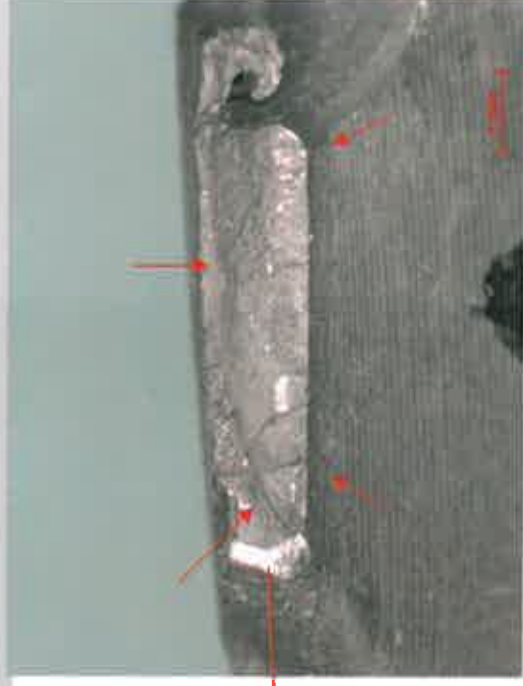
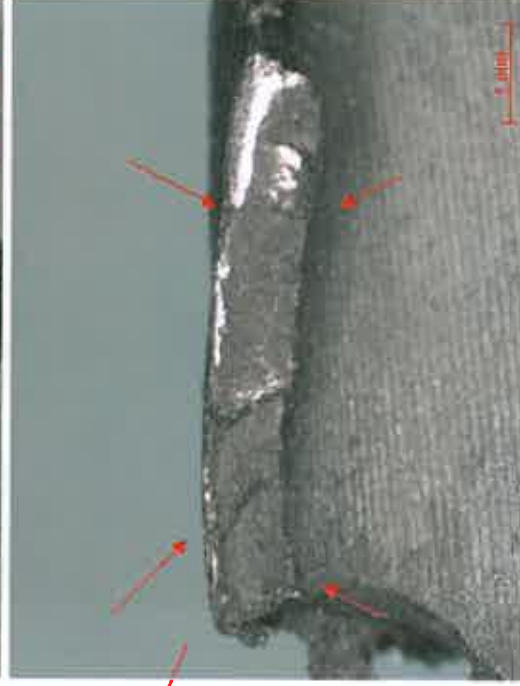
HPT Diffuser Aft Seal

Fractured lug with fatigue fracture indications
